F-3-40
Guilford
(Ellmar, Homewood, Resurvey of Locust Level)
5927 New Design Road
Frederick
Private

**NATIONAL REGISTER OF HISTORIC PLACES
REGISTRATION FORM**

historic name Guilford

Description Summary:

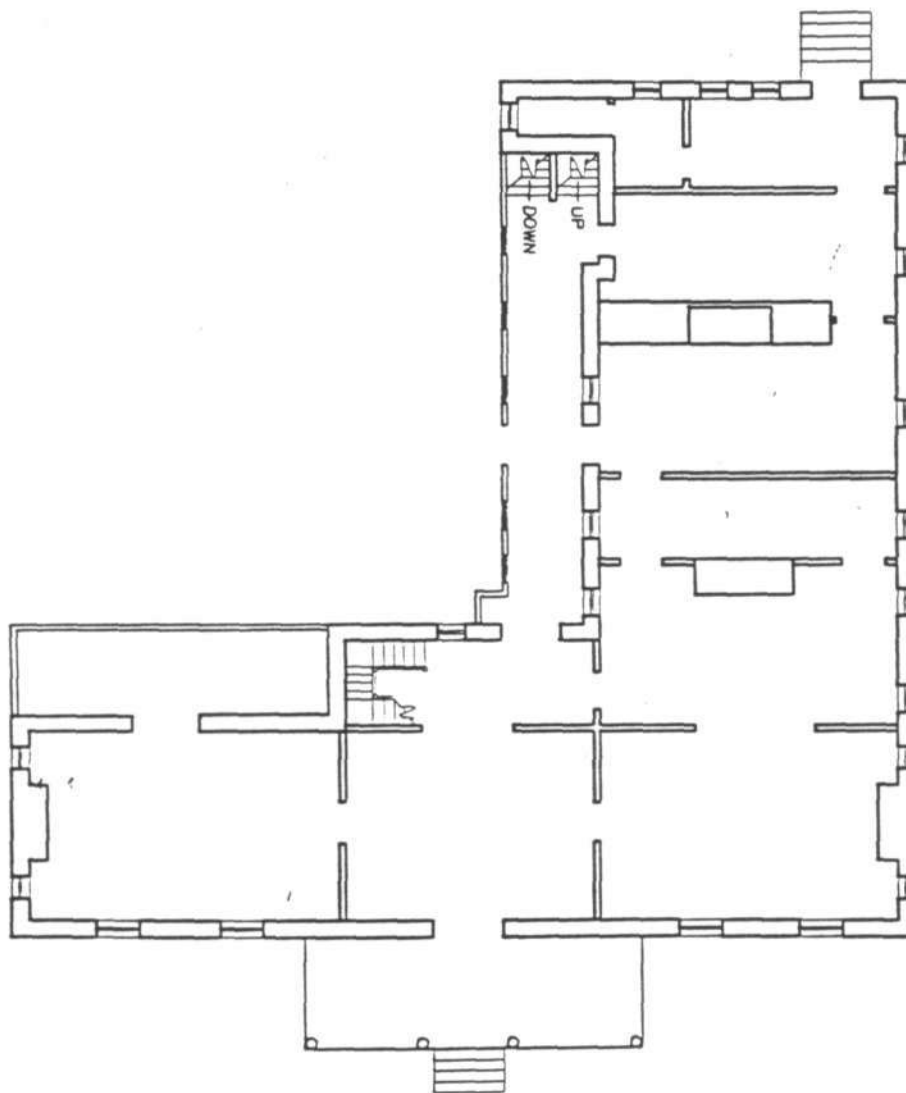
First Floor Plan, Main House

The main farmhouse is a two-and-a-half story, side-gabled, brick dwelling raised on a half-story basement. The main block is five-bays wide and two-bays deep, with a five-bay ell-wing extension. The building is constructed with stucco finished brick walls that rise from a stone foundation. The roof is clad with slate shingles and is punctuated by gable dormers. Parapet walls and interior double-chimneys are located at the gable ends of the principle block.

include chair rails, baseboards, and simple cove moldings (added later). The north parlor also features a plaster top molding adorned with rosette corner blocks. The windows perhaps contain the most elaborate architectural finishes. Recessed window openings are framed by paneled casing with reeded stiles and rails. The casing is embellished with bullseye corner blocks. Each window also features a recessed wood panel with a raised oval motif located under the sill. Identical oval panels also are found above the doorways in the central hall. Similar baseboards, door, and window treatments are utilized throughout the house. The oval window panels are repeated in the front rooms on the second floor.

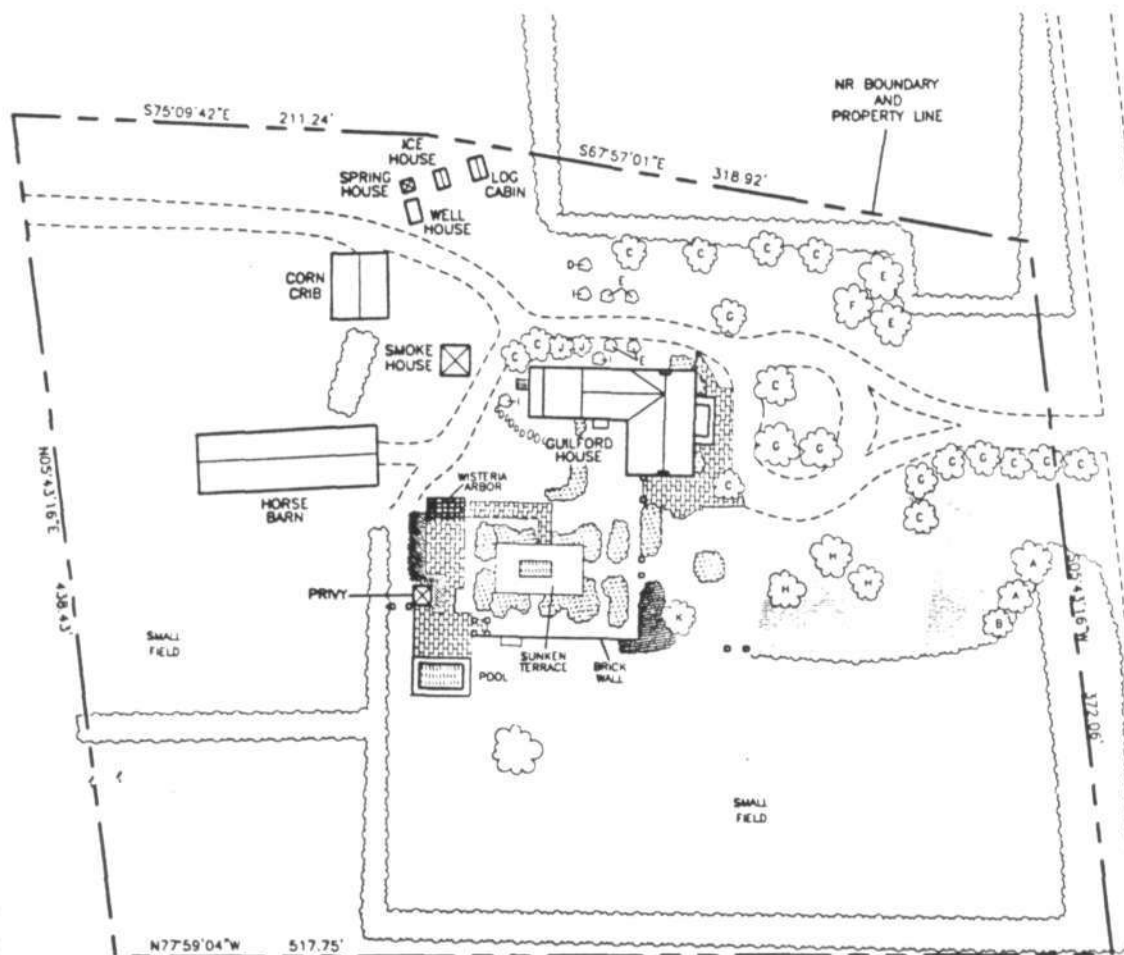
Site Sketch Map; broken line indicates National Register boundaries

Verbal Boundary Description: The nominated property is indicated by the broken line on the accompanying map entitled "Guilford Property, Site Sketch-Map" (see continuation sheet, Section 7, Page 18).

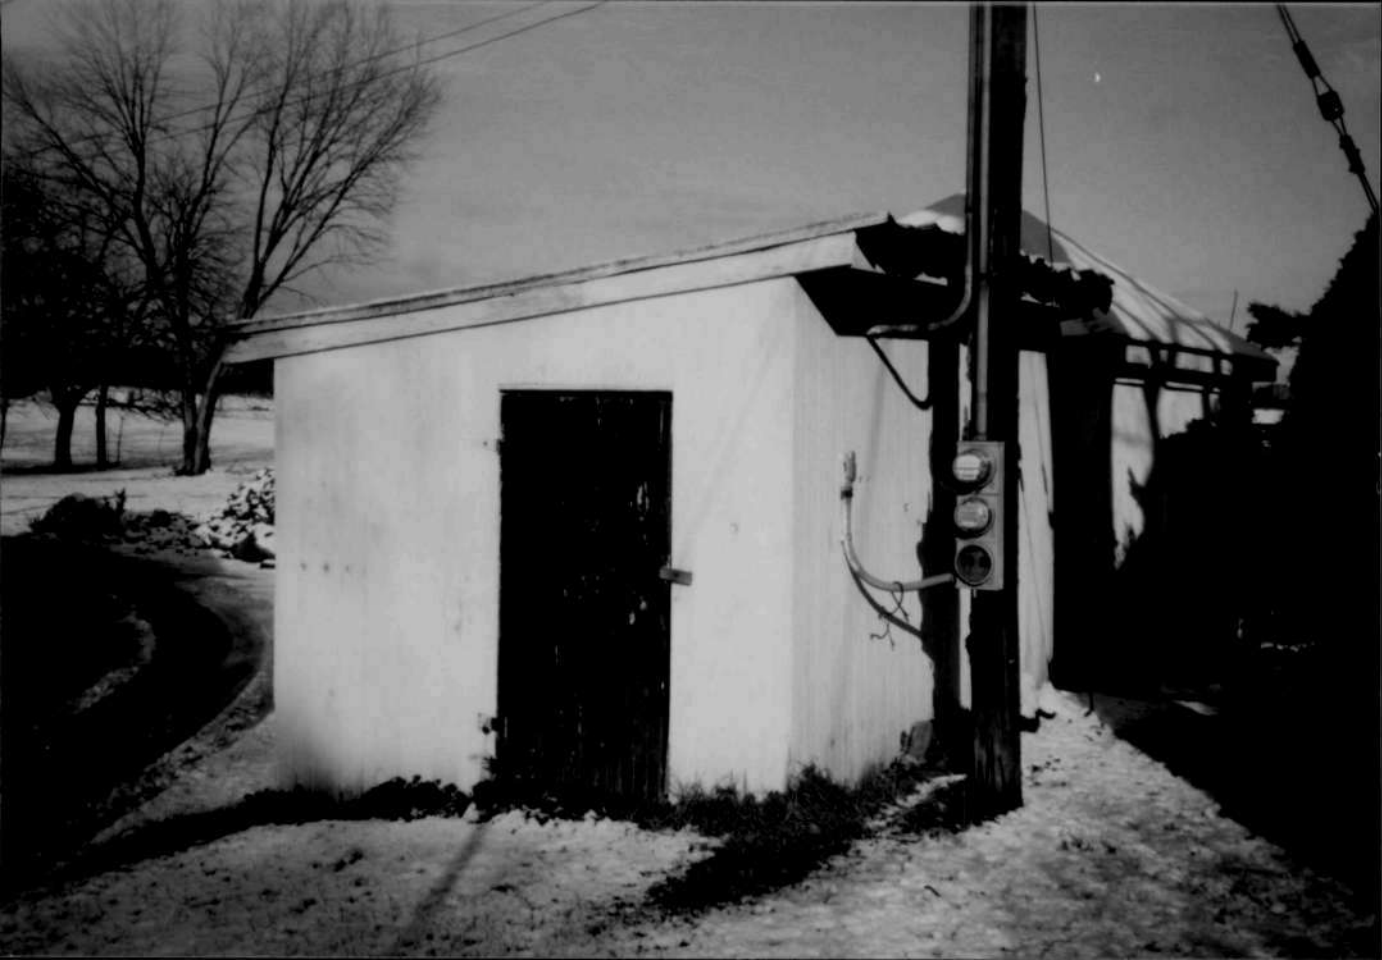
14:17

WELL HOUSE FACING ~~150~~ 207701

The well house is one-story, wood frame structure that measures nine and one-half by fourteen feet. Raised on a stone foundation, the walls terminate in a metal standing seam shed roof. The walls are finished with vertical lapped siding. Six-light casement windows punctuate the east and west elevations. A single vertical plank wood door is located on the south elevation. This building is currently used for storage.

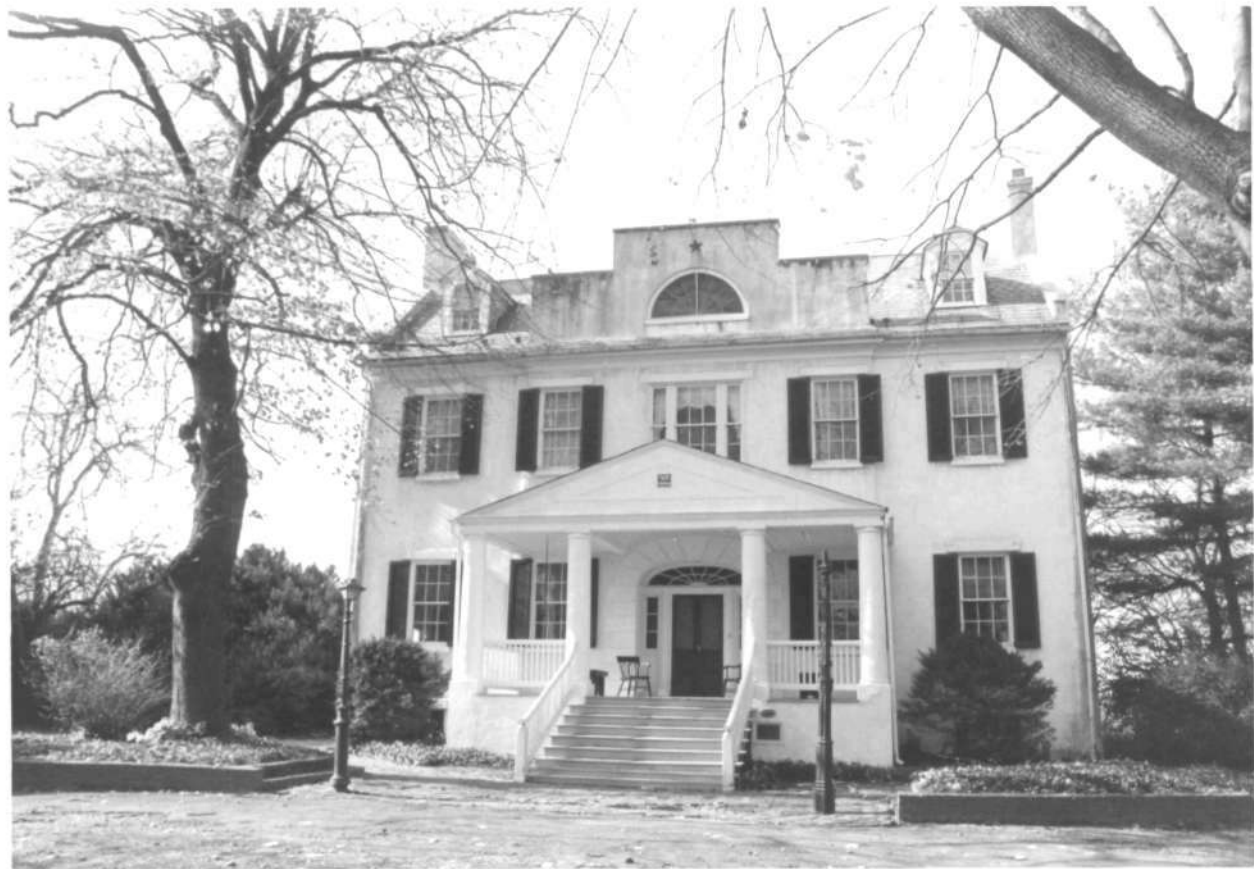
1/17

East elevation

The principal elevation, which measures approximately 49' wide, is symmetrically balanced defined by five-ranked window fenestration, a central one-story pedimented portico, a central three-part (compound) window on the second story, and a large central stepped parapet with lunette window. The windows on the facade are six-over-six, double-hung wood sash with wooden shutters, and stone lintels and sills. Each lintel is embellished with bullseye corner blocks. Gable dormers with six-over-six, double-hung wood sash flank the stepped parapet.

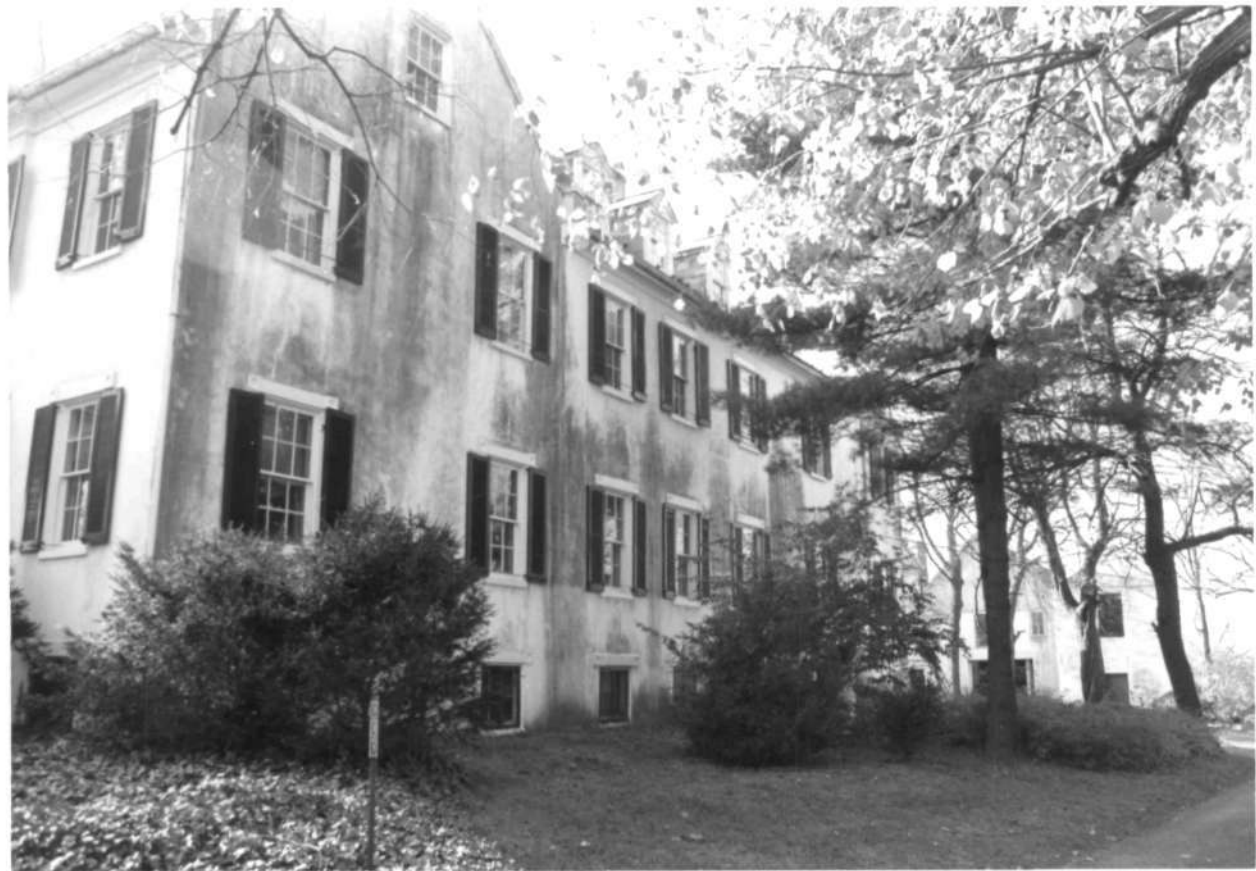
2/17

North elevation

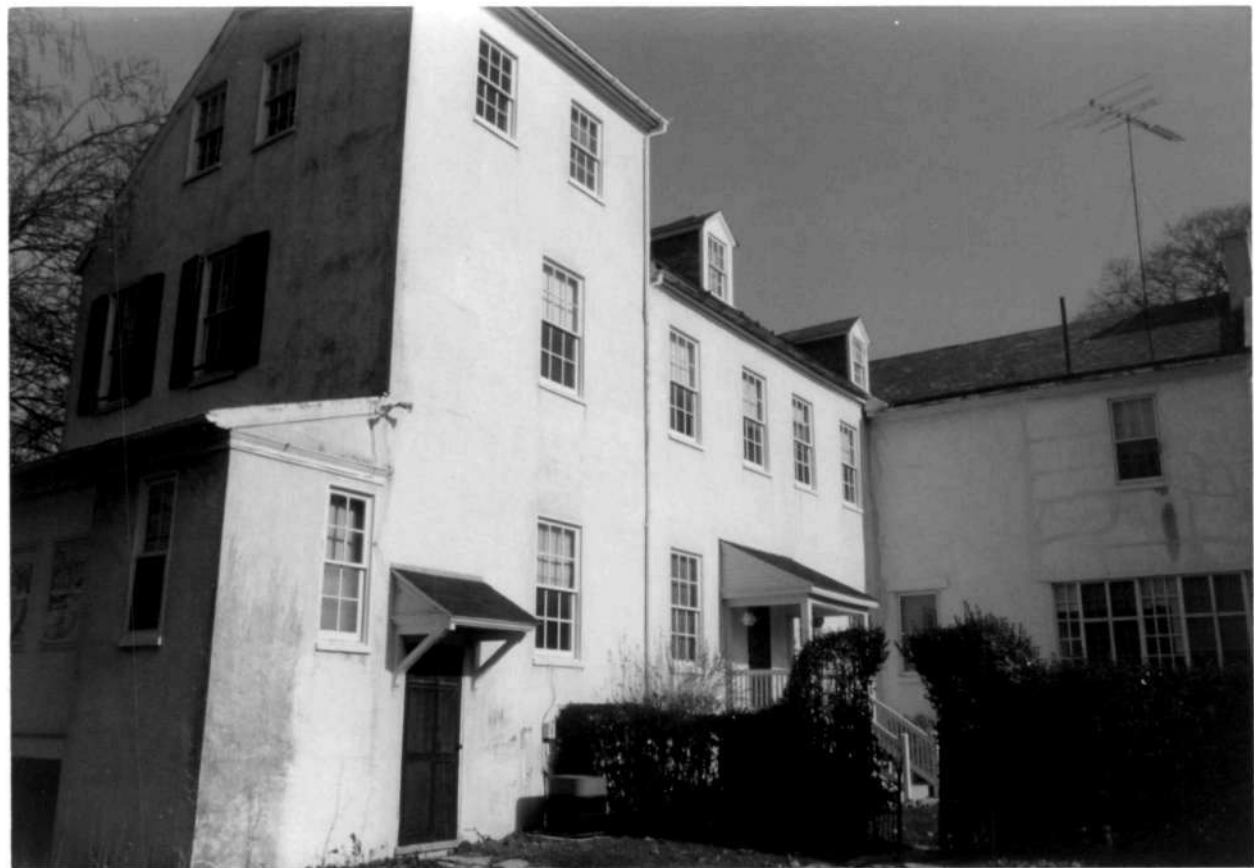
3/17

Southwest corner view of rear wing

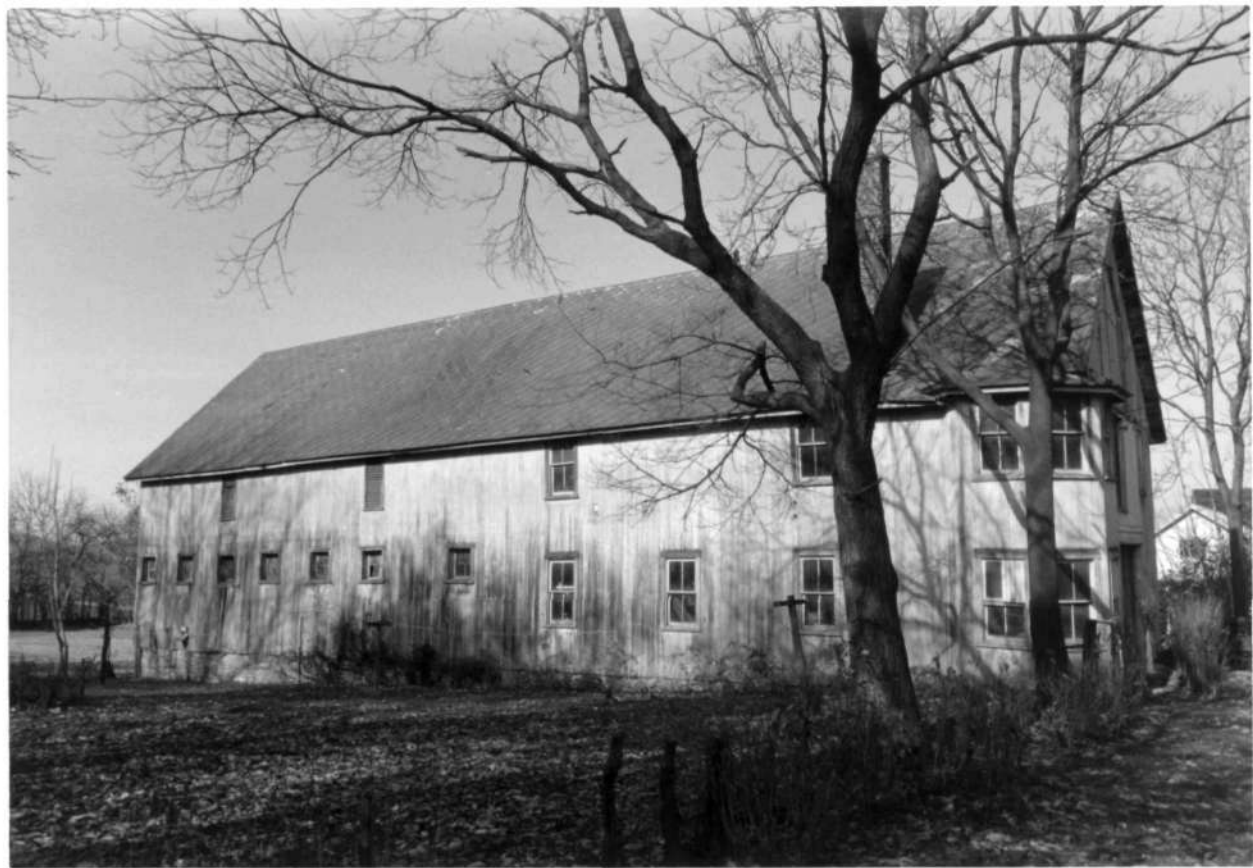
5/17

Horse barn, south elevation

The first story of this building has been converted into a garage and storage area. The second story primarily contains the hay loft. However, a portion has been converted into a small two room apartment which has since been abandoned. The condition of the building is unkempt but generally sound. Termite damage to structural members on the west elevation is extensive.

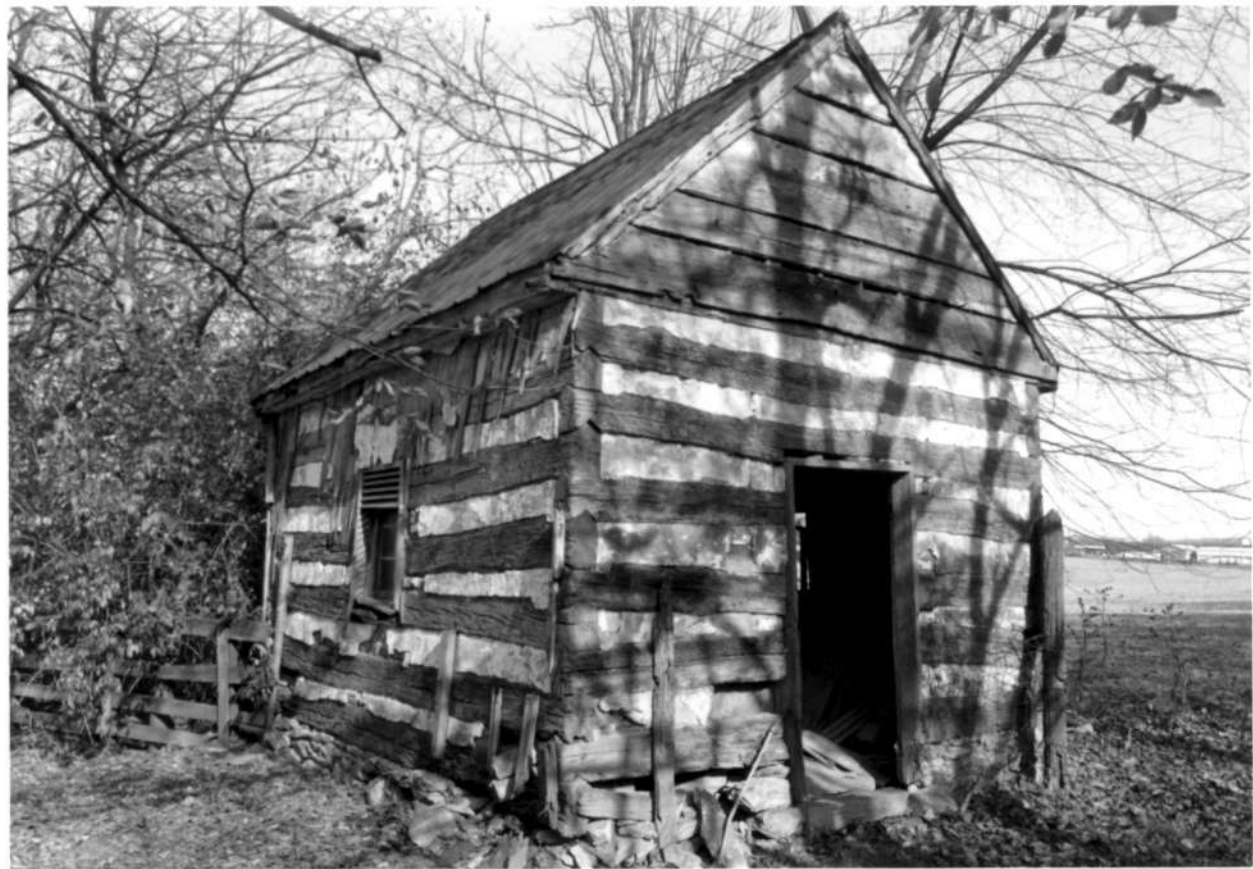
7/17

Log outbuilding, South elevation

This building is a twelve by sixteen foot, one-story, single-pen log cabin. It is constructed with v-notched horizontal hewn timbers set on a field stone foundation. The log walls are constructed in alternating tiers with brick, mud, and mortar chinking. Existing lathing strips and siding indicate the walls were clad in vertical wood siding. The walls terminate in a front gable roof with boxed eaves. The gable ends are clad with horizontal wood siding. The roof is covered with standing seam metal. A single entrance is located on the south elevation. There currently is no door in this opening. The east and west elevations each contain a centrally located, six-light, wood casement window. The original use of this cabin is undetermined. More recently, it appears the cabin was utilized for storage. The cabin is now abandoned and significantly deteriorated.

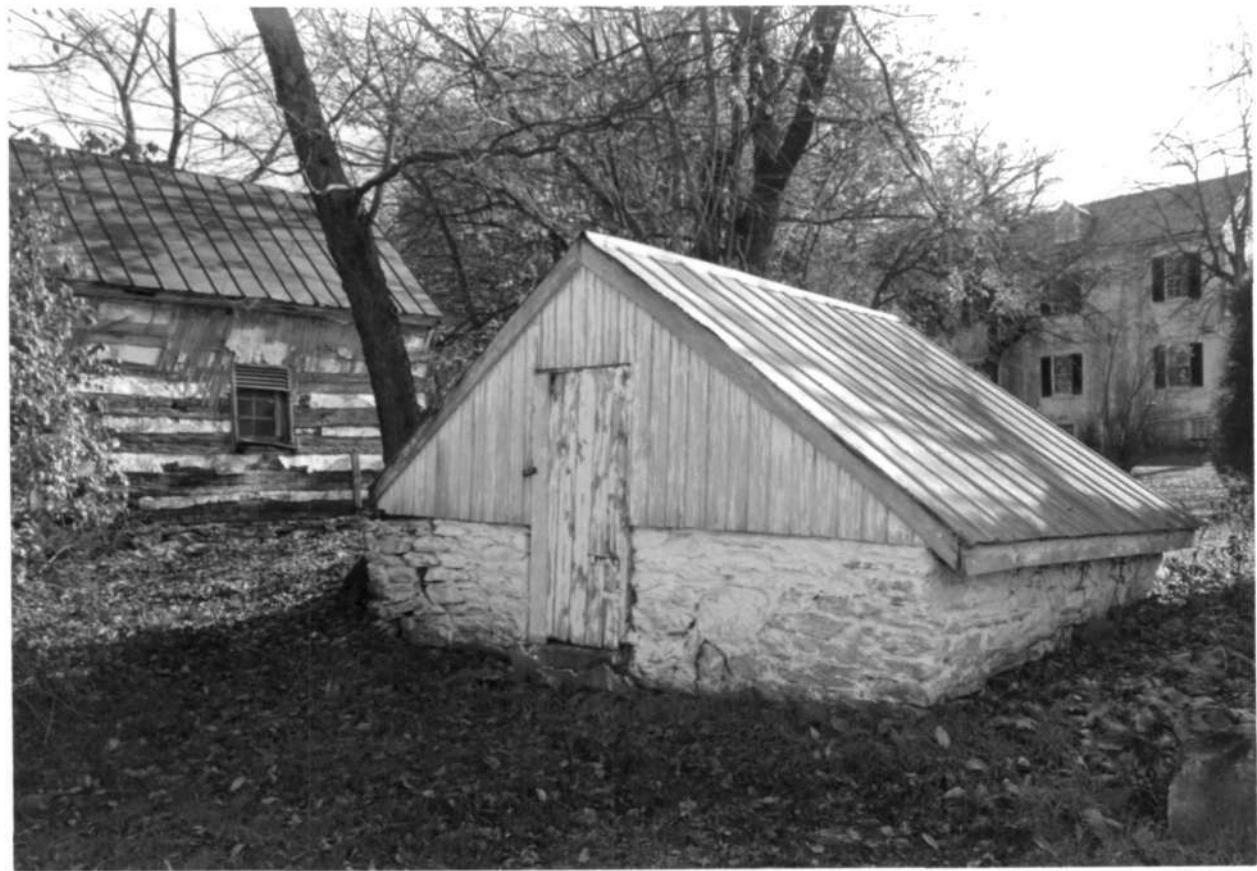
8/17

Ice house, north elevation

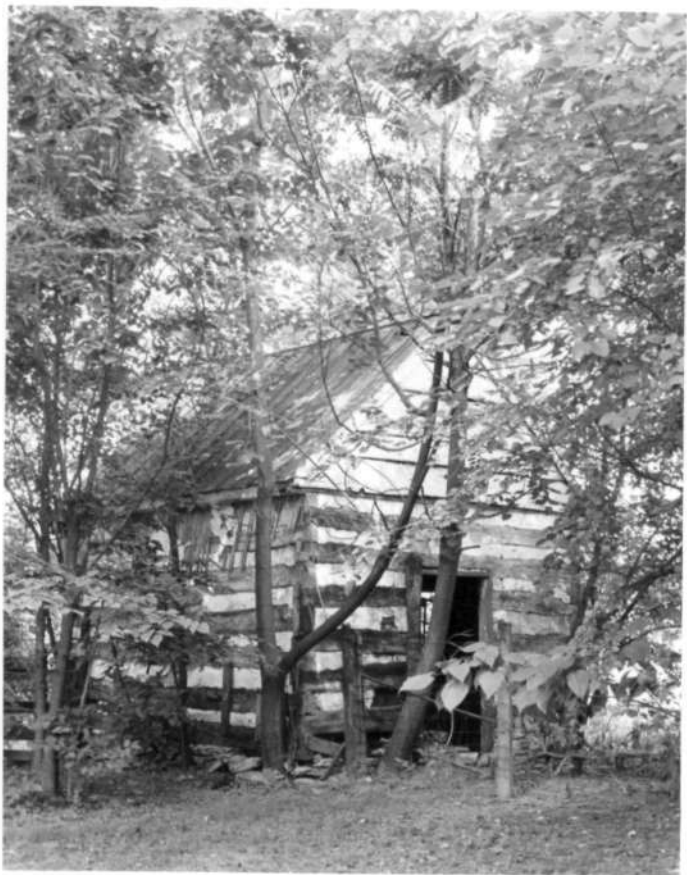
Log cabin
